***CABLE FAILURES AND
PROTECTIVE RELAY OPERATION
ASSOCIATED WITH
NASA GLENN'S
10x10 SUPERSONIC WIND TUNNEL***

Cass Kuhl
Hadron, Inc
NASA Glenn Research Center
Cleveland, Ohio

Supersonic Tunnel Association International Meeting
University of Notre Dame
April 2002

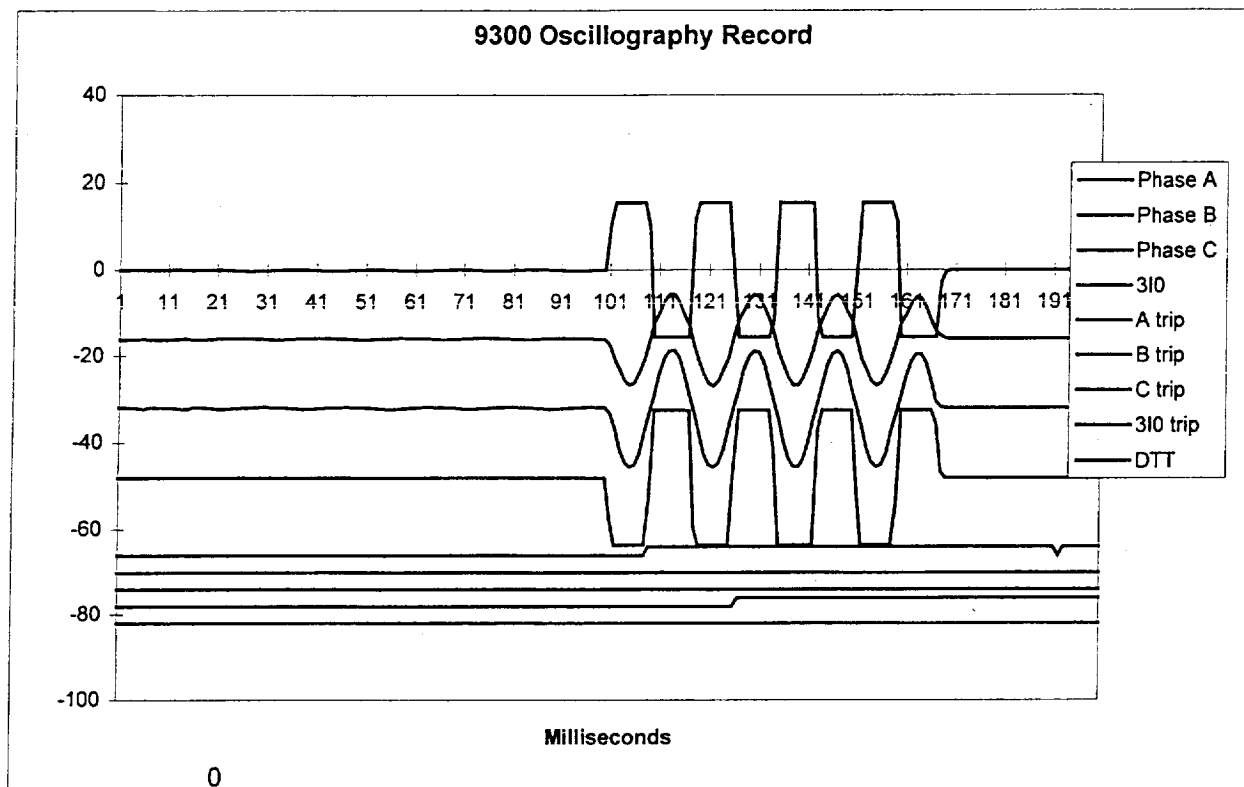
Figure 5 – Substation A – RFL9300 Event Plot for *QA10D1* PH-A Fault

Relay event data was downloaded for all the relays associated with QA10D1 line. Event plots and phasor diagrams appear in Figures 5 – 12. From this data, it was obvious that a fault had occurred on QA10D1 and was most likely a single phase-to-ground fault on phase A.
